# Army Lodging Wellness Recommendation

## Fort Bragg - Final Submittal

August 15, 2003

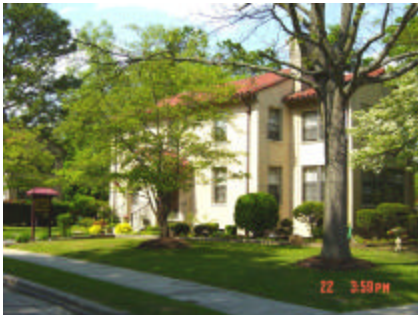
### ***Lodging Building 1-4428 (Normandy)***

Building 1-4428, constructed in 1935, has 2 standard and 18 multi-room suites. The building is in poor condition and does not meet Lodging standards. The cost to make condition assessment improvements will exceed the 50% replacement cost.

Our recommendation is to remove 1-4428 from the Lodging inventory, allowing the installation to determine an alternate use the facility. This

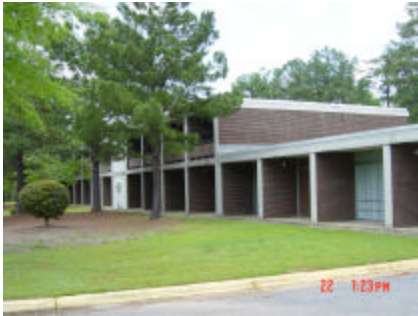
***Lodging Building 5-5047 (Leal)***

Building 5-5047, constructed in 1969, has 24 standard rooms. The building is in poor condition and does not meet Lodging standards. The cost to make condition assessment improvements will exceed the 50% replacement cost.

Our recommendation is to remove 5-5047 from the Lodging inventory, allowing the installation to determine an alternate use for the facility. This facility will be removed from the Fort Bragg Wellness Solution and Lodging Master Plan.

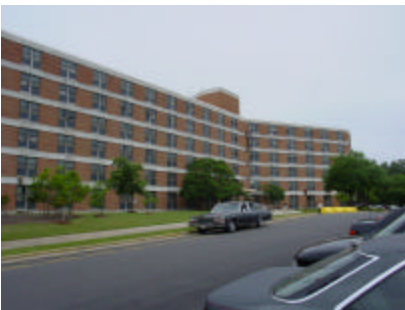
***Buildings D3705 and D3601 (Hardy & Moon)***

Buildings D3705 and D3601, constructed in 1966, are large, nearly identical 6-story facilities with 258 & 242 standard rooms and 8 & 16 family suites respectively. Although these facilities were renovated recently, they still have significant system deficiencies and do not meet Lodging standards. The cost to make condition assessment improvements will exceed the 50% replacement cost.

Our recommendation is to remove D3705 and D3601 from the Lodging inventory, allowing the installation to determine an alternate use for these facilities. These facilities will be removed from the Fort Bragg Wellness Solution and Lodging Master Plan.

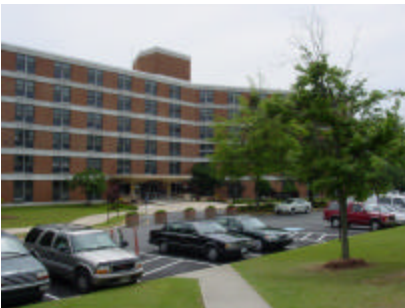
***Lodging Building D4215 (Delmont)***

Building D4215, constructed 1971, has 74 extended stay rooms. This facility is in poor condition and does not meet Lodging standards. The cost to make condition assessment improvements exceed the 50% replacement cost.

Our recommendation is to remove D4215 from the Lodging inventory, allowing the installation to determine an alternate use for the facility. This facility will be removed from the Fort Bragg Wellness Solution and Lodging Master Plan.

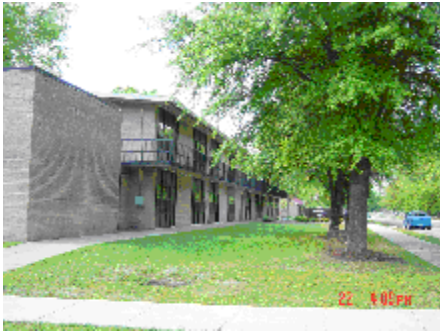
*Building 1-1939 (Forrestal Hall).*

Condition Assessment Cost	\$1,508,535.00
Replacement Cost	\$2,897,230.00
Condition Assessment to Replacement Cost Ratio	52.07%

Because the Condition Assessment to Replacement Cost Ratio is greater than 50%, renovation of Building 1-1939 is not recommended.

- Analysis: The exterior walls on the lodging building are brick veneer in good condition. The exterior walls of the separate mechanical building are also brick veneer but are cracking and disintegrating. These walls are in poor condition.
- Recommendation: Replace the brick veneer on the mechanical building.

- Analysis: The roof is a slightly sloped built-up roof with ballast. There are no gutters. This roof was replaced in 1996 and is in good condition. The mechanical building is a flat roof with single-ply membrane roof in good condition.
- Recommendation: Install gutters and downspouts.

- Analysis: Hot water is produced from a gas-fired boiler. There was no storage tank - the hot water tank mount was empty and there was no indication of an internal tank in the boiler. The boiler was replaced in 1997 and is in good condition but there are still hot water shortages. The circulating pumps are in good condition. Most mechanical room piping has been replaced but the building system piping is original and is considered to be in poor condition.

- Analysis: This building did not contain a sprinkler system.
- Recommendation: Install new sprinkler system.
